An Intrauterine Contraceptive Device that Migrated to the Bladder and Encrusted

Mehmet Gökhan Çulha, Bülent Mansuroğlu, Nejdet Karşıyakalı, Uğur Yücetaş, Ali Ferruh Akay

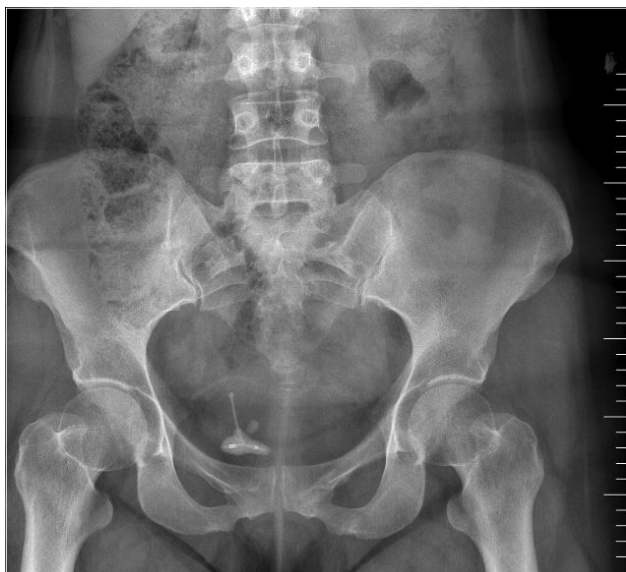
Figure 1. Encrusted intrauterine contraceptive device in the pelvic area. Plain abdominal radiography image.

Plain radiography of the pelvis should be the first diagnostic procedure when the strings of IUD cannot be observed in a vaginal examination, is not detected in the endometrial cavity using ultrasonography (9). In this case, chronic inflammation of the uterine wall may lead to the migration of the IUD and result in calculus formation.

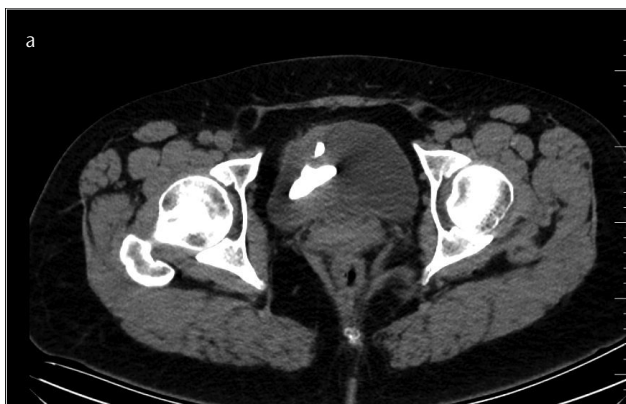
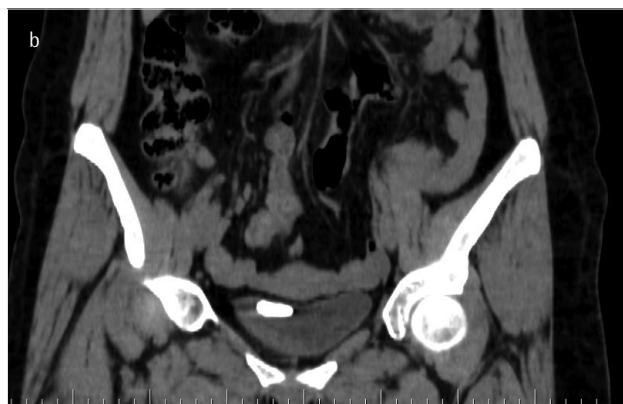
Figure 2. a, b. Image of the intrauterine contraceptive device that migrated to the bladder and the stoned device on performing computer tomography (a: axial section). Image of the intrauterine contraceptive device that migrated to bladder and the device on performing computer tomography (b: coronal section).
